Lake Bluff Public Library Building Systems and Site Report

Revised | November 14, 2023

2022 Existing Conditions and Revision Recommendations Lake Bluff Public Library Lake Bluff, Illinois Visit Date: September 9, 2022

Lake Bluff Library Facility Assessment Report

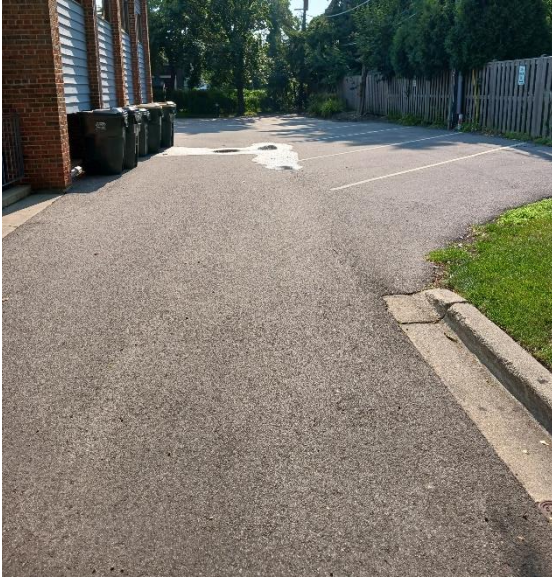
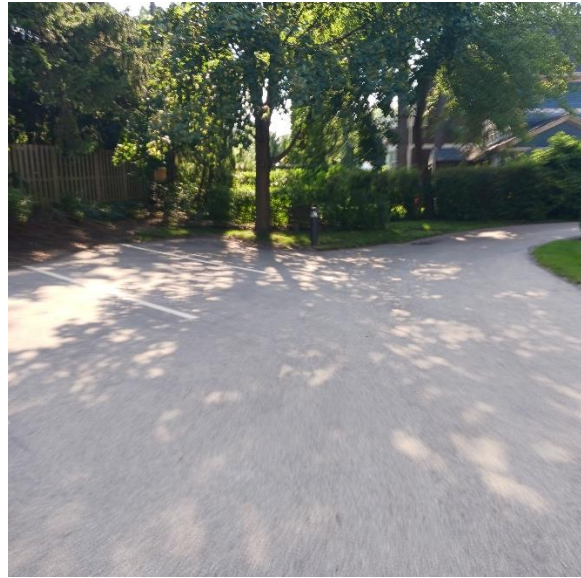
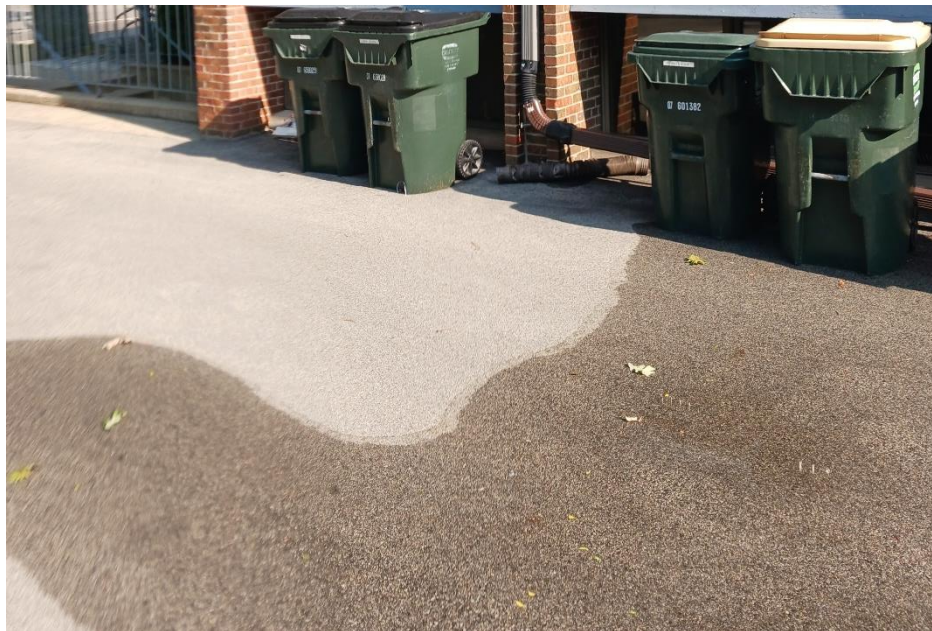
The onsite asphalt is aged but appears to have minimal cracks. Seal coating every other year is recommended to extend the life of the pavement. Ponding is apparent in the middle of the parking area, due to minimal ground slope. Regrading the area or adding a structure are potential solutions. A topographic survey would be necessary to determine the best solution.

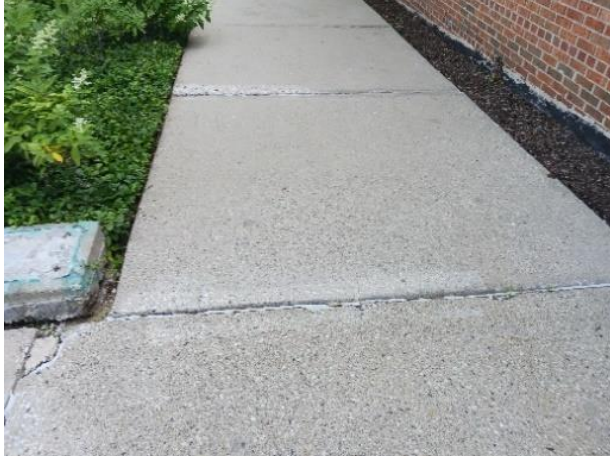
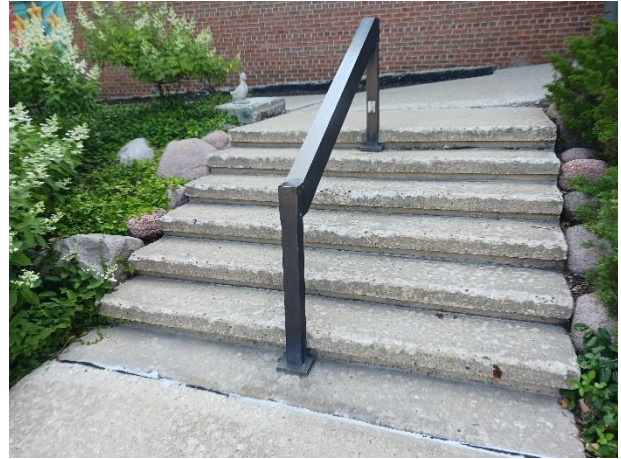
The site's sidewalks show significant signs of wear. The western walk from the Scranton Avenue sidewalk to the doorways has differential settlement, is old and pitted. To eliminate the bumps created by the differential settlement, edges of the sidewalk have been ground down. Gaps are present between sections of the sidewalk. Additional gapping is present by the stairs to the west of the walk. The concrete stairs are worn. The hand railing seems insufficient.

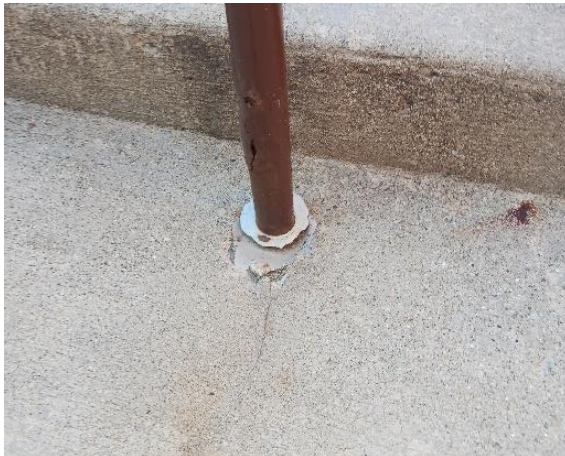
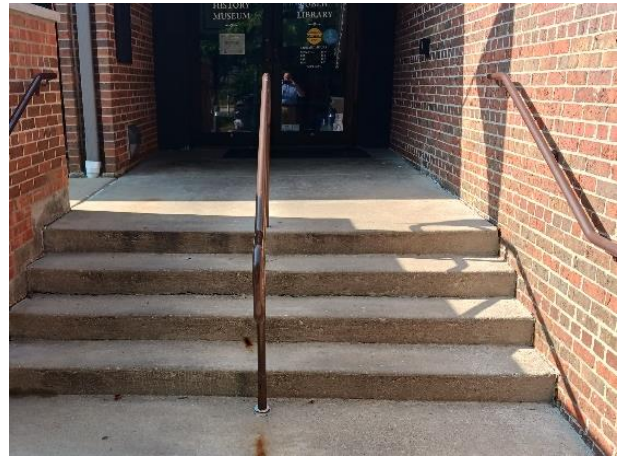
The rail at the main entrance is loose at the bottom of the stairs, is cracked, and does not appear to meet ADA requirements since the rail does not extend 12" past the stairs. The rail in the picture above also does not appear to meet this requirement.

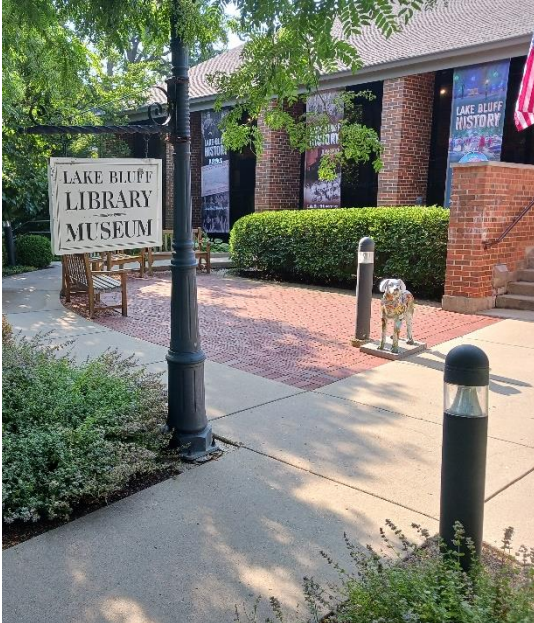
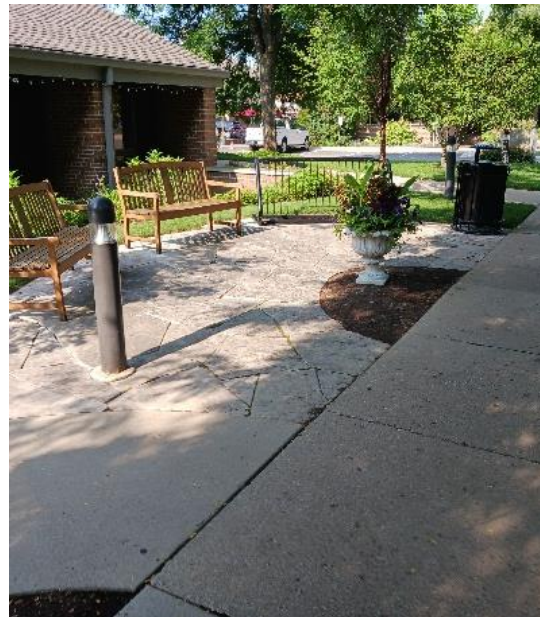
The brick paver plaza appears to exceed a 2% slope and therefore does not meet ADA requirements. It is not an ADA path so it does not have to meet ADA requirements but as a public meeting space, the library may want the plaza to be accessible. The stone pavers east of the main entrance appear to be heaving and edges of the stones may need to be grinded down to minimize the elevation change between stone pavers.

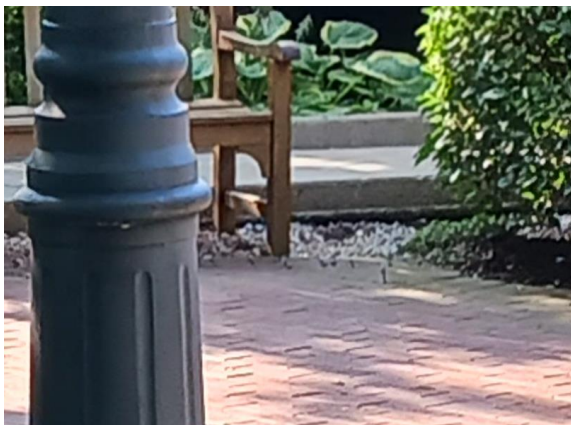
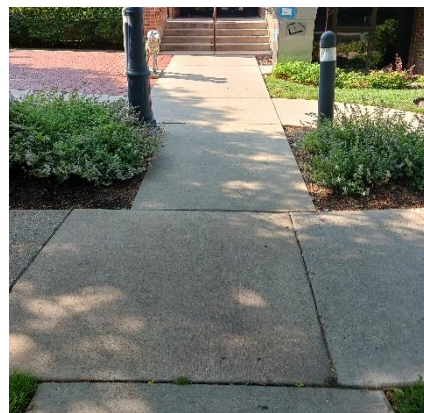
The looping ramp located at the front of the property appears to be ADA compliant, although a survey is required to verify. The eastern portion of the ramp is undermined, with the bottom exposed. This should be backfilled / mud-jacked to avoid future issues. The intersection with the public walk and the main walkway appears to have a greater than 2% slope and is not ADA compliant. The public walk would need to be adjusted to address this issue.

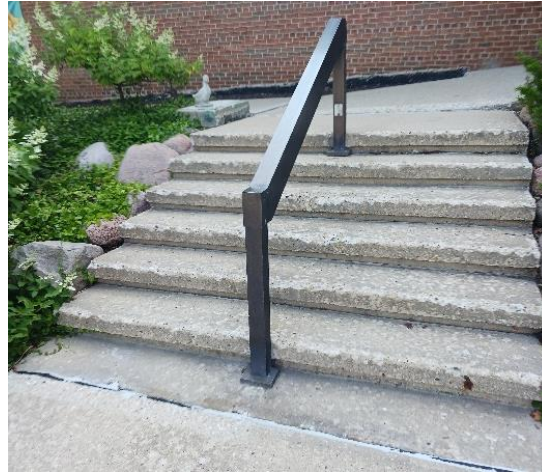
The railing at the west entrance does not meet the ADA length requirement. The landing at the top of the stairs does not meet ADA level landing requirement in size nor slope (required 5' by 5' landing with maximum 2% slope in any given direction).

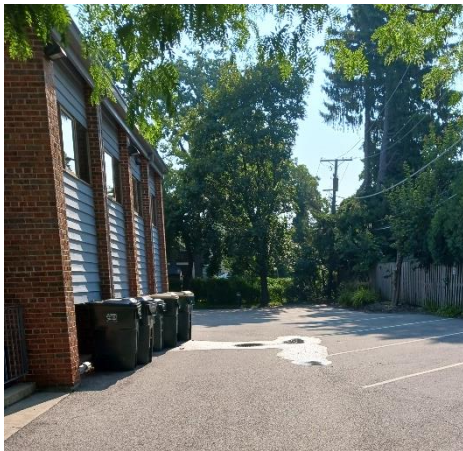
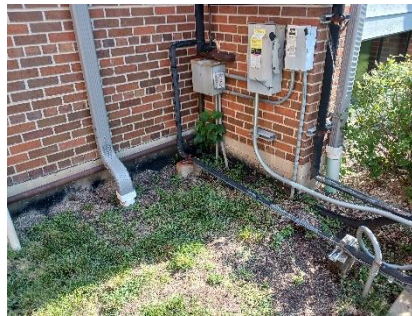
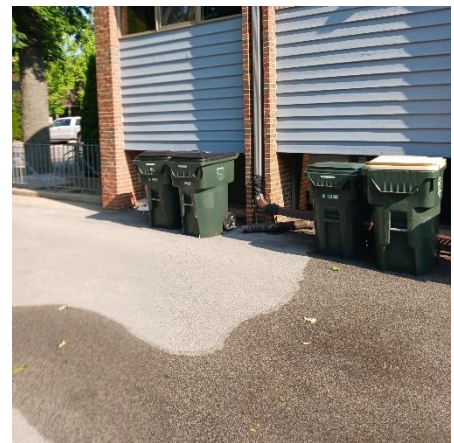
Standing water is present in the south parking lot. Some downspouts drain into the ground, while others drain onto the surface. There appear to be leaks in downspouts on the building's front side that are splashing onto the pavement.

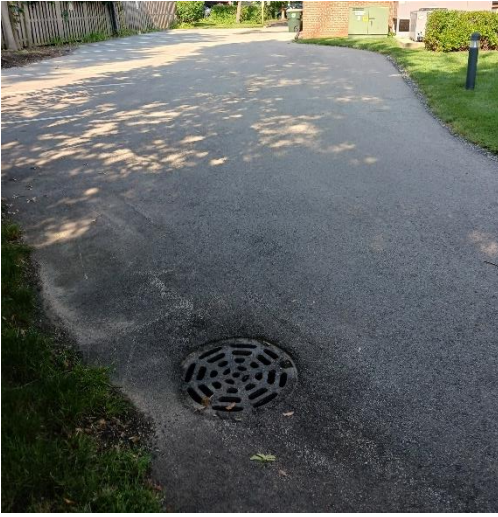
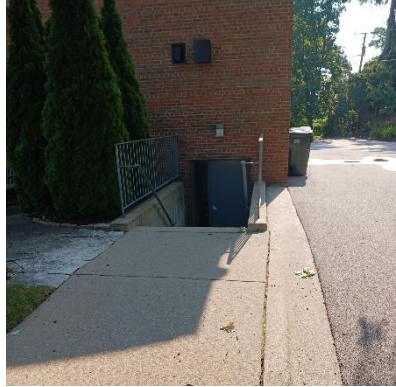
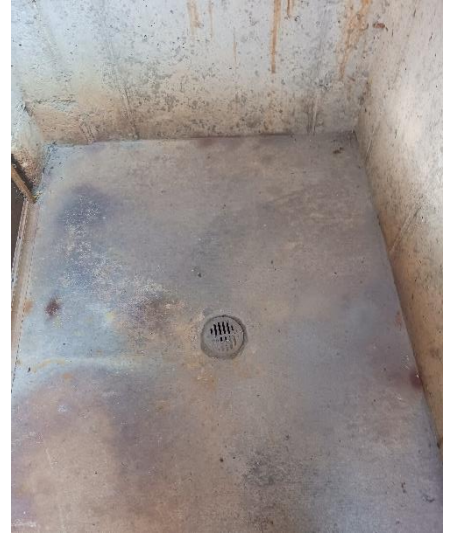
There are two stormwater structures onsite. The first seems to receive water from the neighbor's yard and drains to the north right-of-way. The second is located at the bottom of the depressed staircase on the building's east side. The drain looks partially clogged, but there are no signs of flooding. Half of the downspouts go underground. It is likely that the downspouts connect to a storm sewer near the library.

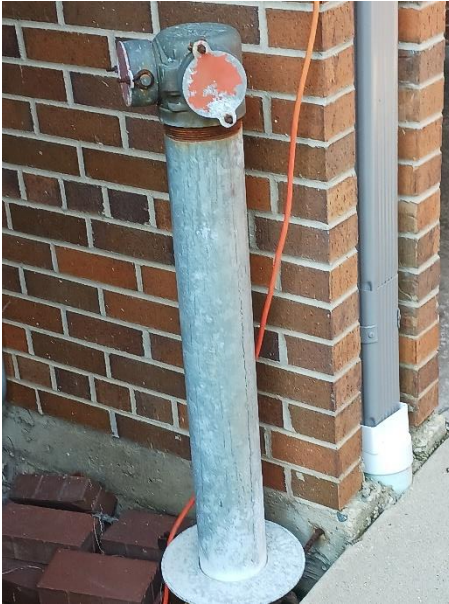
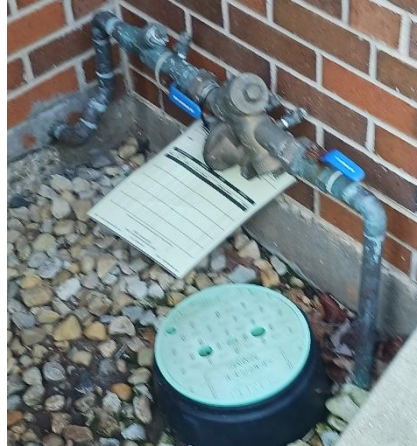
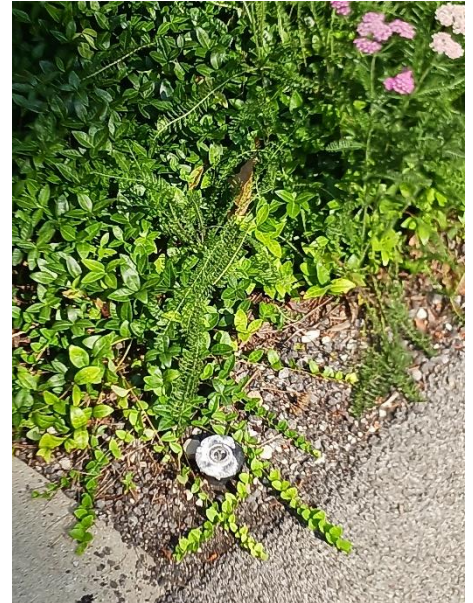
The exterior fire standpipe is loose. It should be anchored into the building. The backflow preventor should be in a secure box enclosure. EEA notes that the site's landscaping is irrigated.

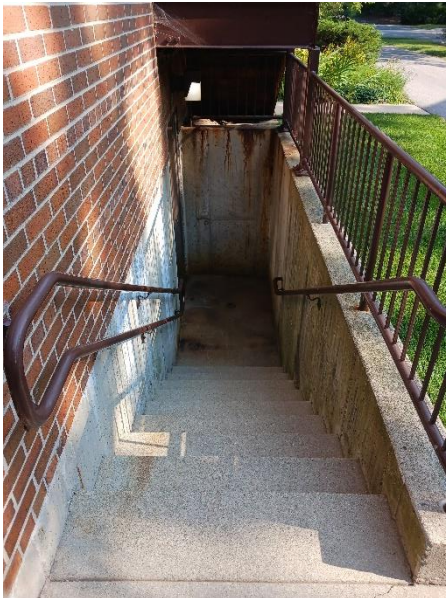
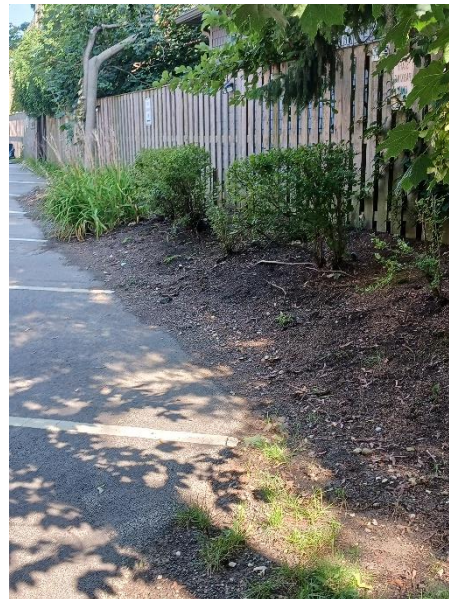
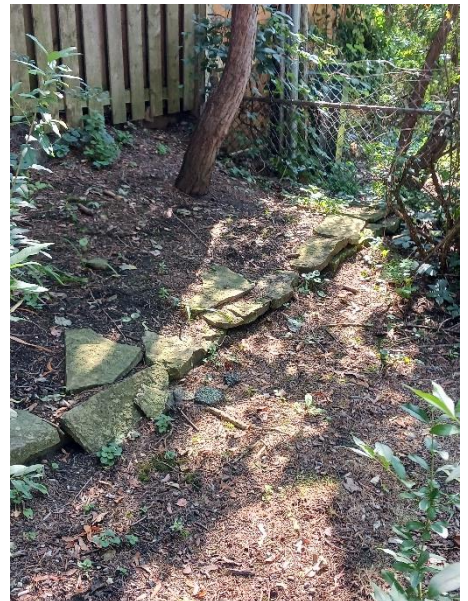
The walls of the east depressed stairwell show rust from the steel rail. There is a wooden fence on the southeast side of the site. It is unclear during the site visit who owns the fence. A natural stone retaining wall is in disrepair in the site's southeast corner. It is not tall and should likely just be removed.

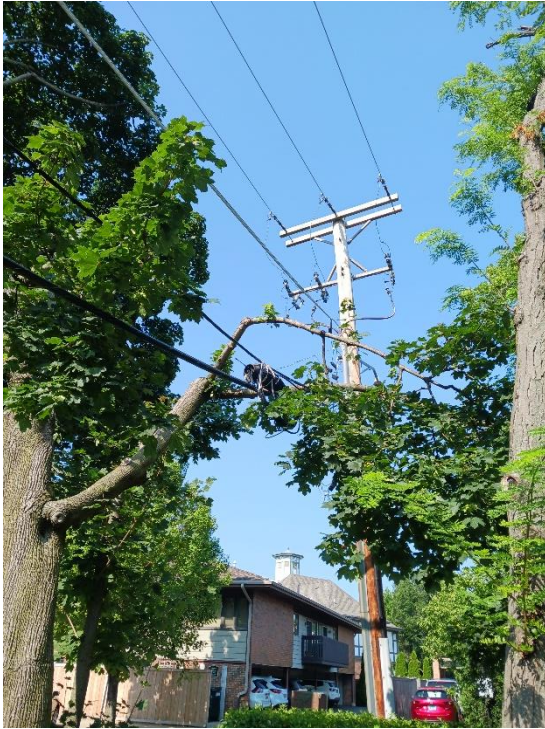
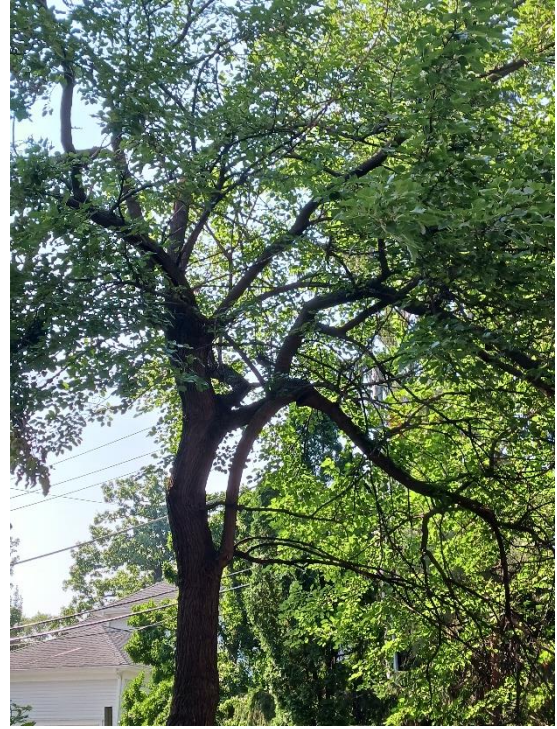
Several tree limbs encroach on overhead utility lines and poles. A certified arborist should dictate trimming decisions.
