# Lake Bluff Public Library Building Systems and Site Report

Revised | November 14, 2023

# Lake Bluff Library Facility Assessment Report

TO: Joe Huberty, Shaun Kelly – Engberg Anderson  
PROJECT: Fox Lake Library Facility Assessment  
DATE: 11/1/2023  
SENIOR PROJECT MANAGER: Ben Ahring, P.E.

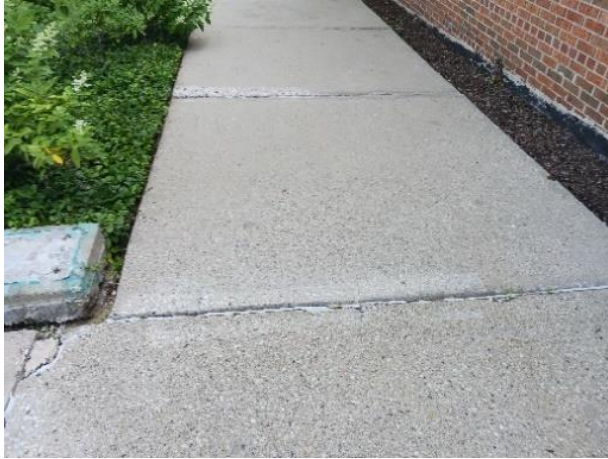
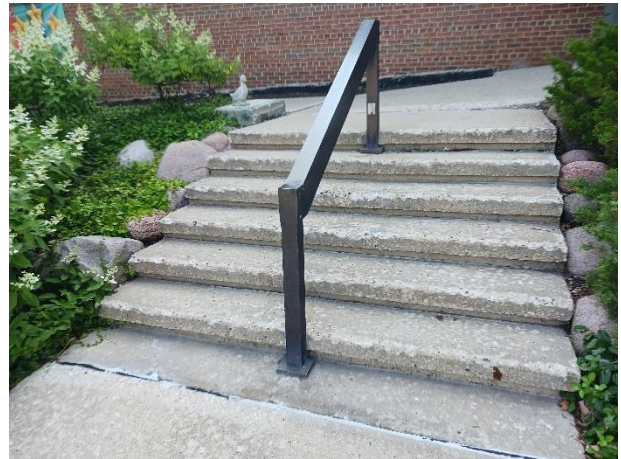
The site's sidewalks show significant signs of wear. The western walk from the Scranton Avenue sidewalk to the doorways has differential settlement, is old and pitted. To eliminate the bumps created by the differential settlement, edges of the sidewalk have been ground down. Gaps are present between sections of the sidewalk. Additional gapping is present by the stairs to the west of the walk. The concrete stairs are worn. The hand railing seems insufficient.

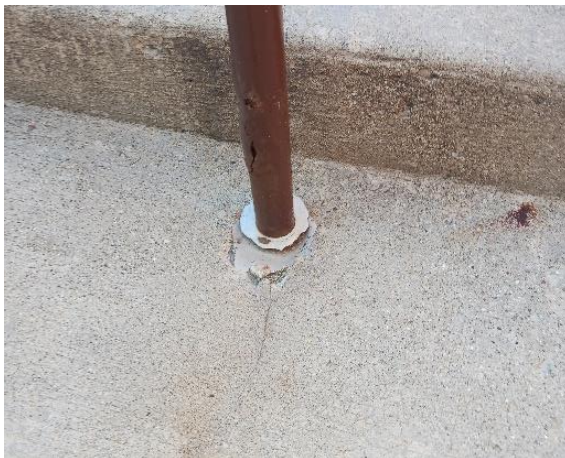
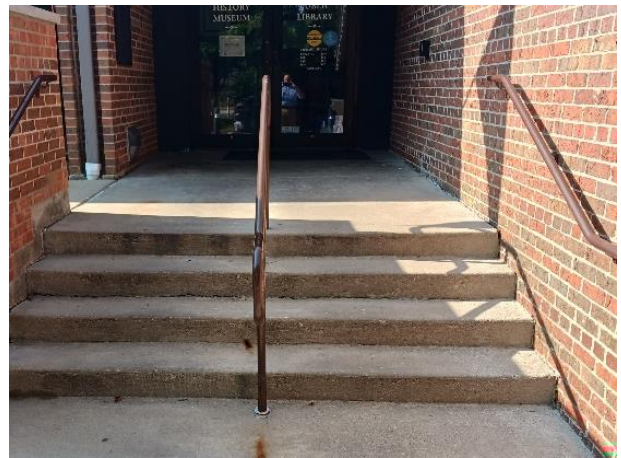
The rail at the main entrance is loose at the bottom of the stairs, is cracked, and does not appear to meet ADA requirements since the rail does not extend 12" past the stairs. The rail in the picture above also does not appear to meet this requirement.

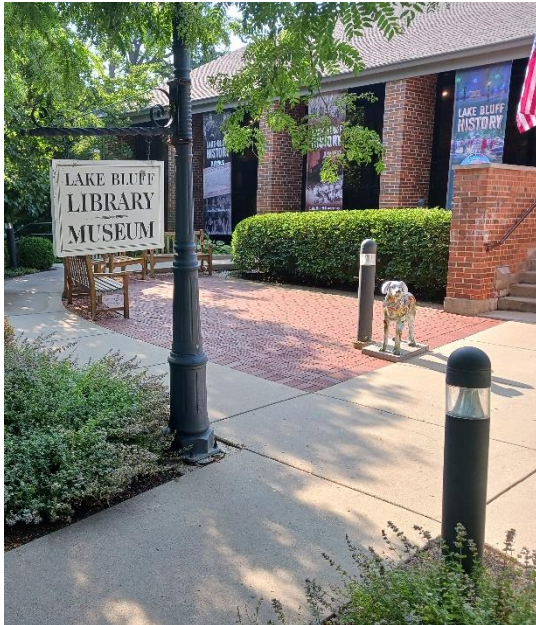
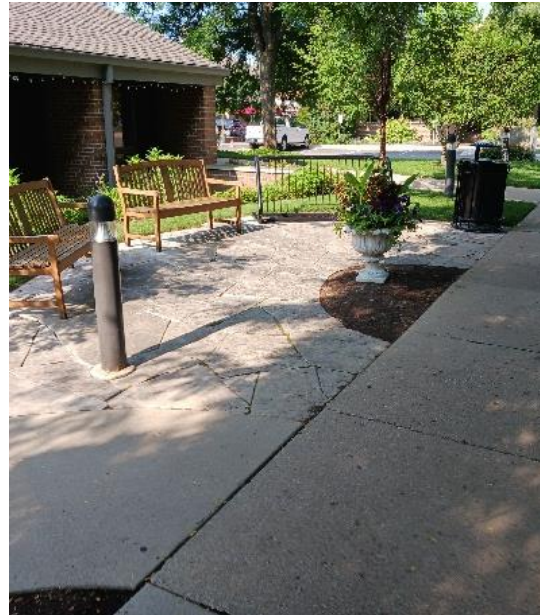
The brick paver plaza appears to exceed a 2% slope and therefore does not meet ADA requirements. It is not an ADA path so it does not have to meet ADA requirements but as a public meeting space, the library may want the plaza to be accessible. The stone pavers east of the main entrance appear to be heaving and edges of the stones may need to be grinded down to minimize the elevation change between stone pavers.

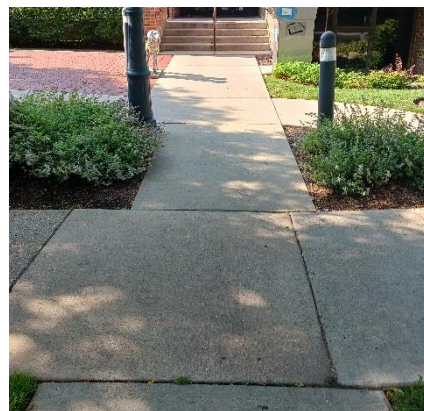
The looping ramp located at the front of the property appears to be ADA compliant, although a survey is required to verify. The eastern portion of the ramp is undermined, with the bottom exposed. This should be backfilled / mud-jacked to avoid future issues. The intersection with the public walk and the main walkway appears to have a greater than 2% slope and is not ADA compliant. The public walk would need to be adjusted to address this issue.

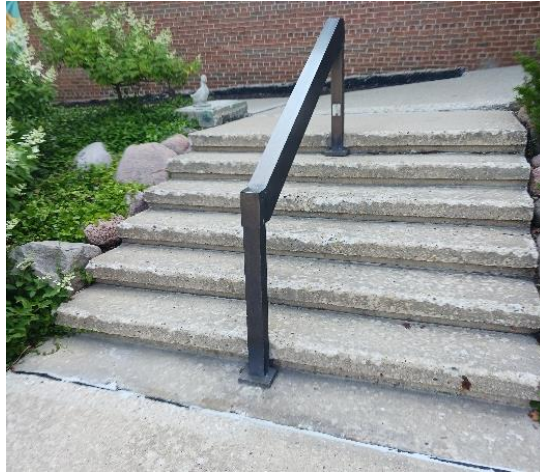
The railing at the west entrance does not meet the ADA length requirement. The landing at the top of the stairs does not meet ADA level landing requirement in size nor slope (required 5' by 5' landing with maximum 2% slope in any given direction).

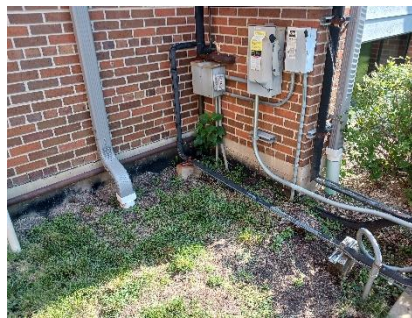
Standing water is present in the south parking lot. Some downspouts drain into the ground, while others drain onto the surface. There appear to be leaks in downspouts on the building's front side that are splashing onto the pavement.

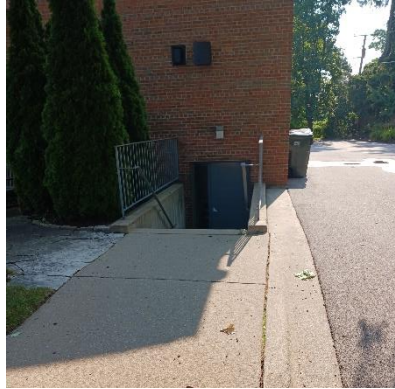
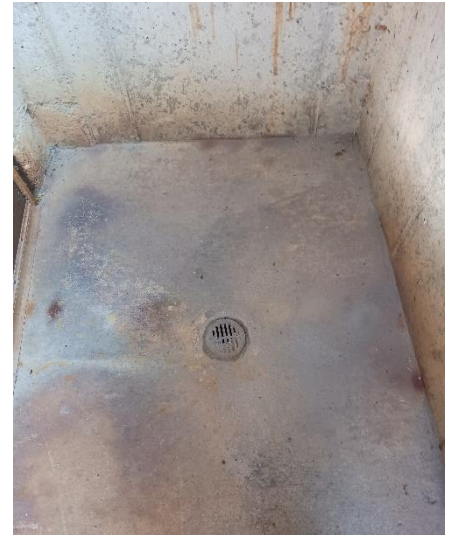
There are two stormwater structures onsite. The first seems to receive water from the neighbor's yard and drains to the north right-of-way. The second is located at the bottom of the depressed staircase on the building's east side. The drain looks partially clogged, but there are no signs of flooding. Half of the downspouts go underground. It is likely that the downspouts connect to a storm sewer near the library.

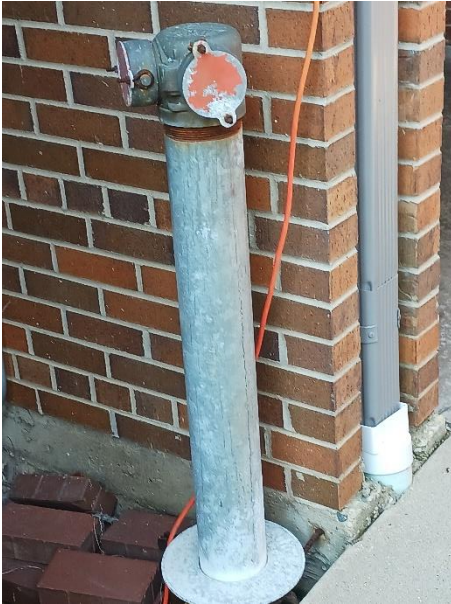
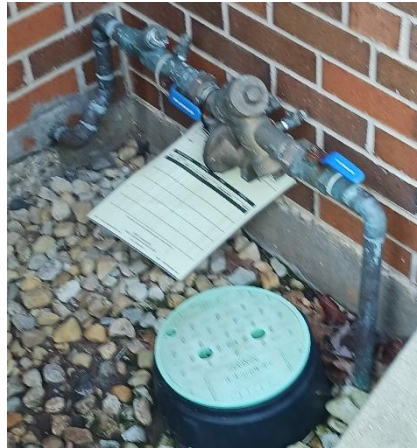
The exterior fire standpipe is loose. It should be anchored into the building. The backflow preventor should be in a secure box enclosure. EEA notes that the site's landscaping is irrigated.

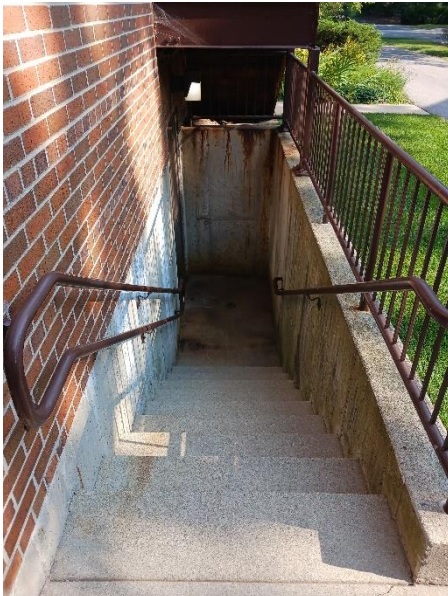
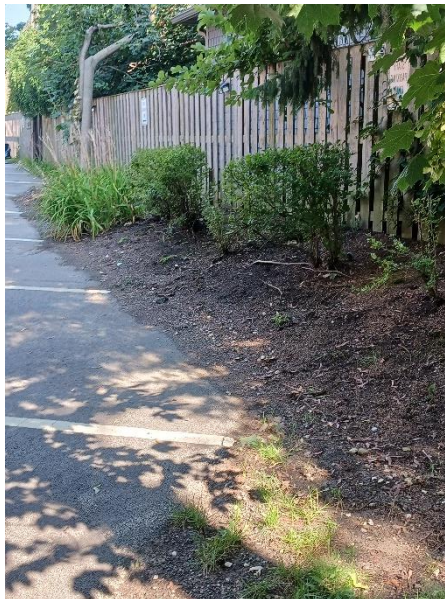
The walls of the east depressed stairwell show rust from the steel rail. There is a wooden fence on the southeast side of the site. It is unclear during the site visit who owns the fence. A natural stone retaining wall is in disrepair in the site's southeast corner. It is not tall and should likely just be removed.

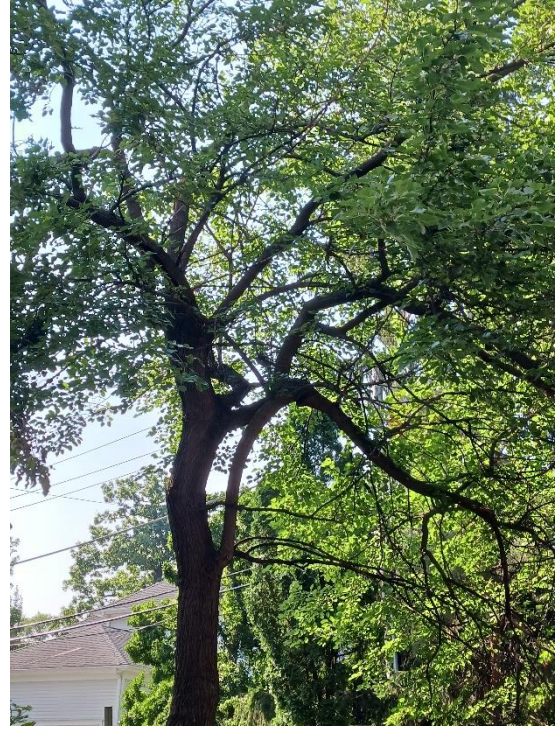
Several tree limbs encroach on overhead utility lines and poles. A certified arborist should dictate trimming decisions.
