Lake Bluff Public Library Universal Design Assessment

DRAFT FOR LIBRARY REVIEW | NOVEMBER 27, 2023

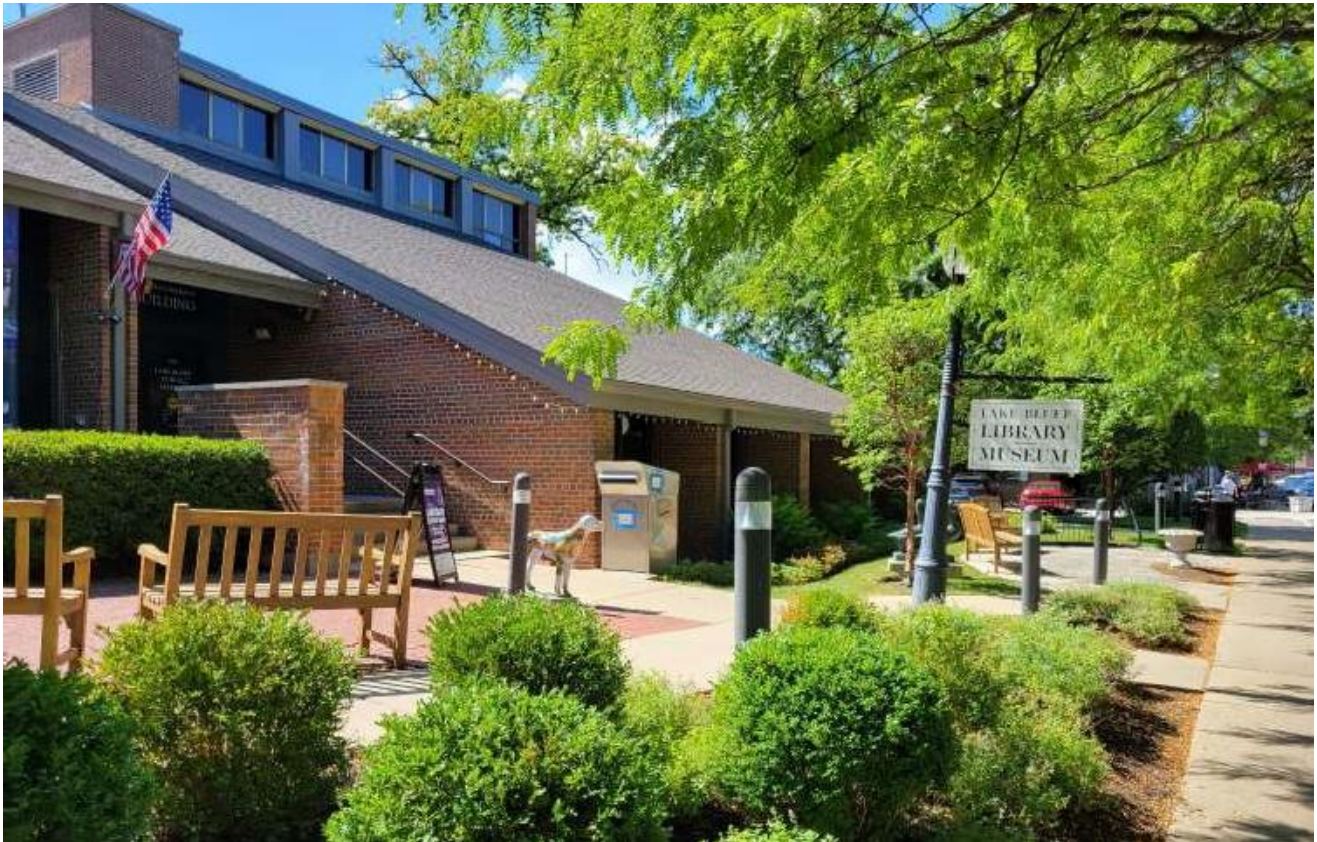
Library Main entry looking west

- ▶ *The Library could benefit from dedicated and increased parking. However, based on the available site and the surrounding neighborhood this is a significant challenge. We recommend the Library discuss this issue with the Village of Lake Bluff to review possible solutions. This will help keep the Library in the broader thinking about Downtown parking.*

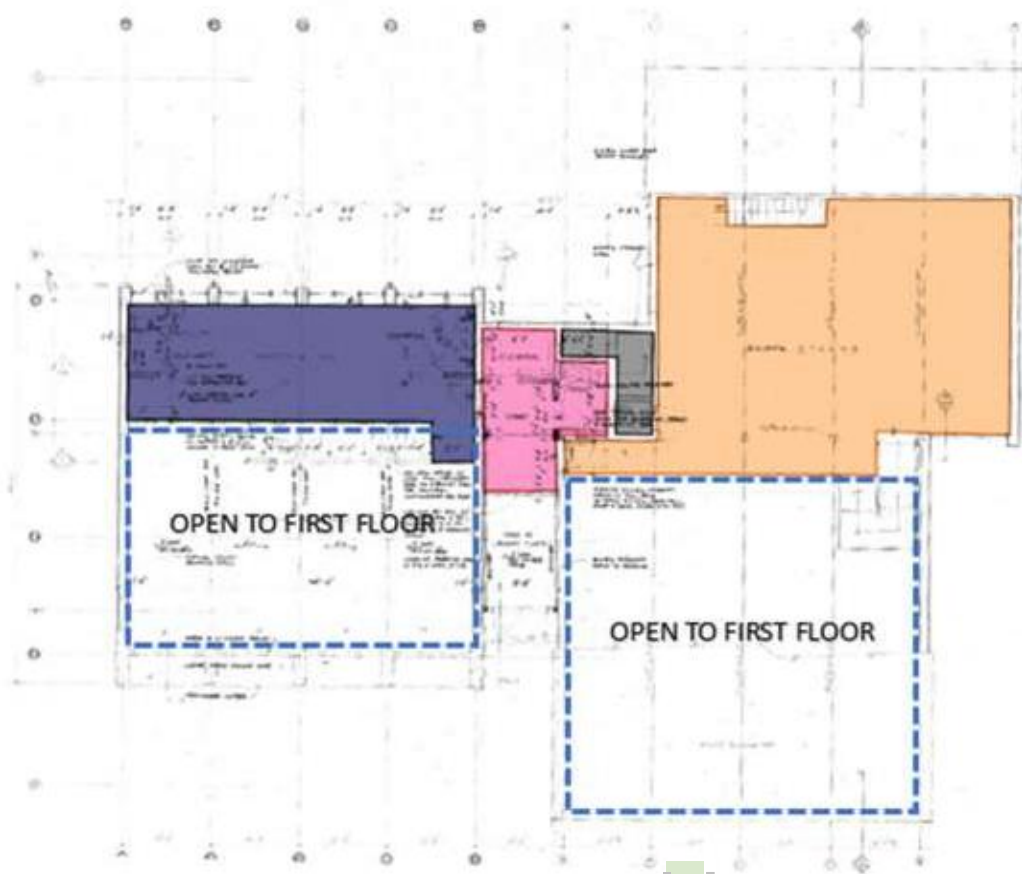
4.

The Mezzanine contains adult collections, study tables/counter and other seating areas. The space is accessible by the main stair, side stair, and elevator through a small corridor space. Other than some issues noted below the only drawbacks of the space are acoustics and vertical access. The space is out of the main traffic zone.

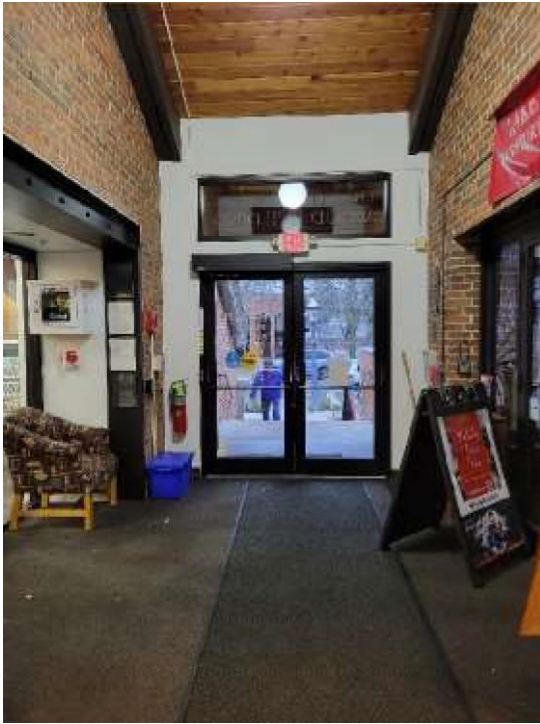
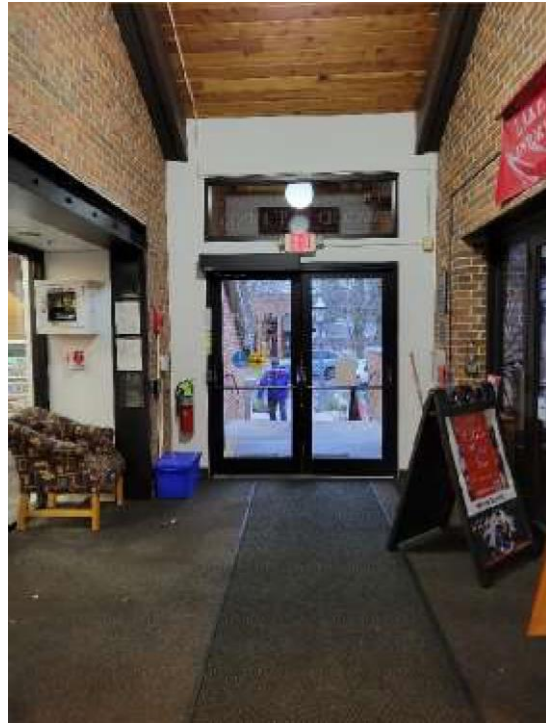
- The building required life safety and accessible signage is not code compliant and is missing in some areas. Room identification signage is strictly governed by accessibility code. Text size, contrast, and pictograms are prescribed by codes and provide a universal experience for all buildings. There are some things that can be customized but the intention is to clearly communicate space information to the broadest population possible.
- The bookstacks also do not have indicators as to how the collection is laid out.

Library Entry looking toward Elevator

Library Entry looking toward Entry/Exit

- ▶ *We recommend looking at arranging the book stacks to make the main stair more visible from the main entry.*
- ▶ *We recommend installing accessibility code compliant room signage at all building spaces.*
- ▶ *We recommend installing architectural wayfinding signage for restrooms, Youth Services, and the meeting space.*

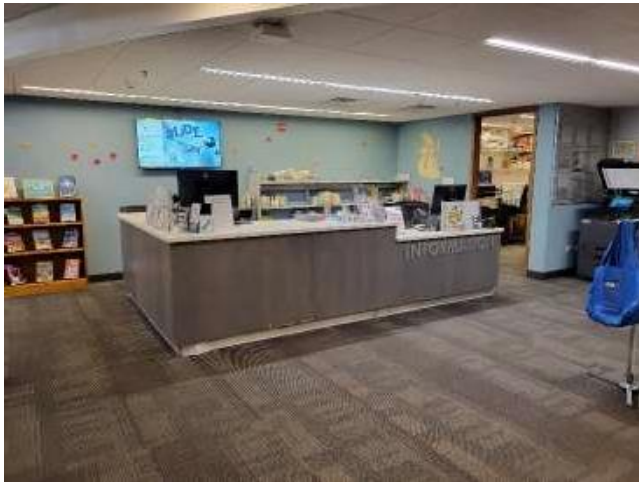
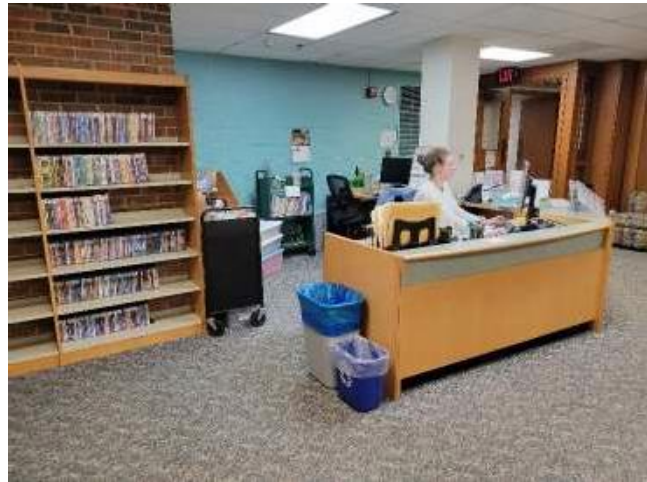
The Library has two primary service points each of which has notable deficiencies.

First Floor Public Service Point

Lower Level Public Service Point

► *The Library should consider options for the main service point. Although it is located conveniently for staff workroom access, it is hidden from patrons as they enter the building via the main entry.*

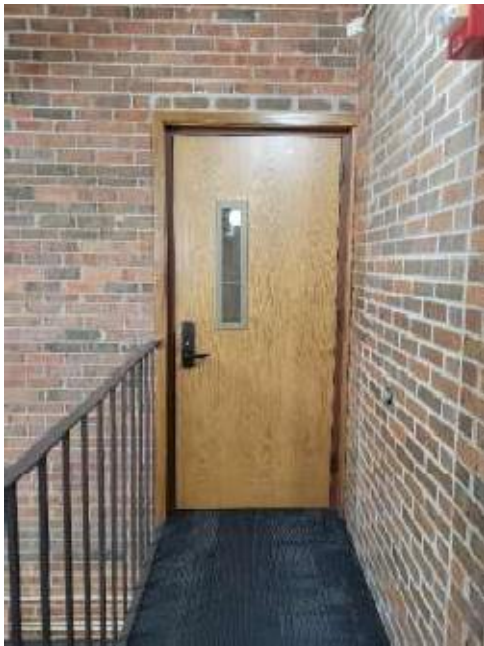
The Mezzanine pathway is a difficult issue. Based on the building constraints there is not an easy solution. The pathway would need to be wider and the door possibly removed. Some modification is necessary to make the Mezzanine an accessible space.

Mezzanine access from elevator

Aisle along Mezzanine seating

► We recommend the library provide an accessible pathway Mezzanine pathway between the elevator and the Mezzanine.

Options could include structurally extending the walkway or removing the door.

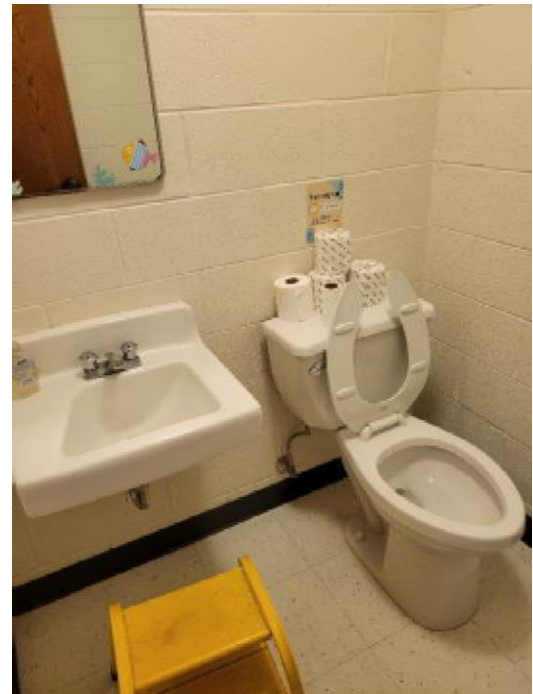
Youth Services Bathroom

The faucets and flush valves are not automatic. Manual sinks can be left running and can be hard to operate for people with mobility issues. Additionally, the Library would like to add automatic openers to the restrooms where possible. This would improve accessibility and hygiene.

- ▶ We recommend each public use restroom have the following toilet accessories: double roll tissue dispenser, soap dispenser, waste receptacle, napkin disposal, hook, baby change station, and either a paper towel dispenser or hand dryer. Faucets, soap dispensers and paper towel dispensers should be automated where possible. Additionally, consideration to a napkin dispenser should be reviewed.
- ▶ All the restrooms are surrounded by structural walls. It will be difficult to modify these spaces to provide the required space. We recommend the Library consider renovating at least two restrooms in the building to meet accessibility requirements.
- ▶ We recommend the Library provide automatic flush valves and sinks.

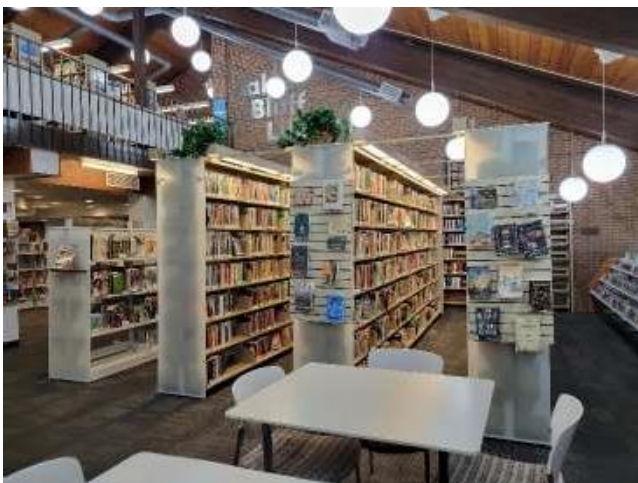
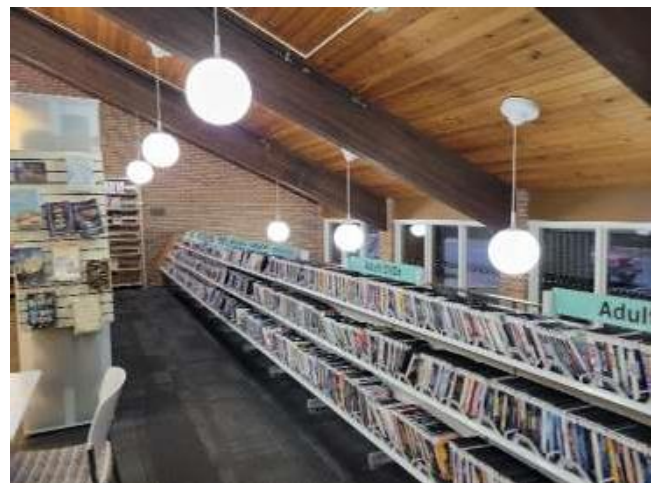
The collection aisles and turning space in many areas does not conform to accessibility code. Please refer to the "Collection" section in the "Accessibility" portion of this report for details. The library does have enough space to shift the shelving to meet aisle clearance requirements of the Illinois Accessibility Code.

The First Floor is generally intuitive to navigate based on the size. The seating and collection area is just inside the main entry. The service desk is a little hidden around a corner but is visible after a few steps. The restrooms and quiet study room are also easily located once inside the space. The main stair is hidden behind book stacks however, it is visible by staff from the main service point.

First Floor of Library

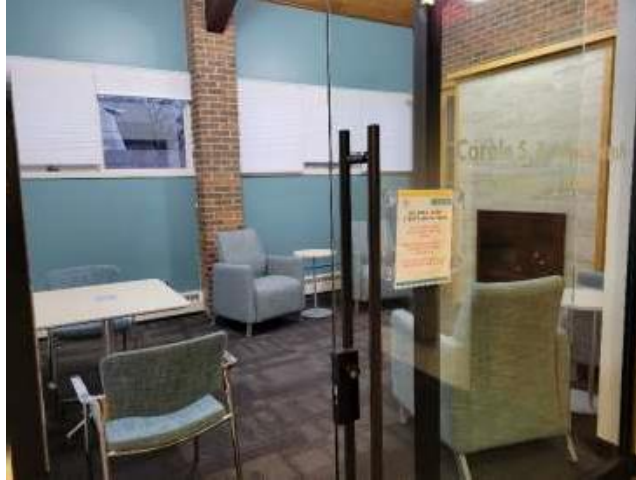
The Stroh Room was recently completed and provides a quite space to the open plan of the Library.

Stroh Room

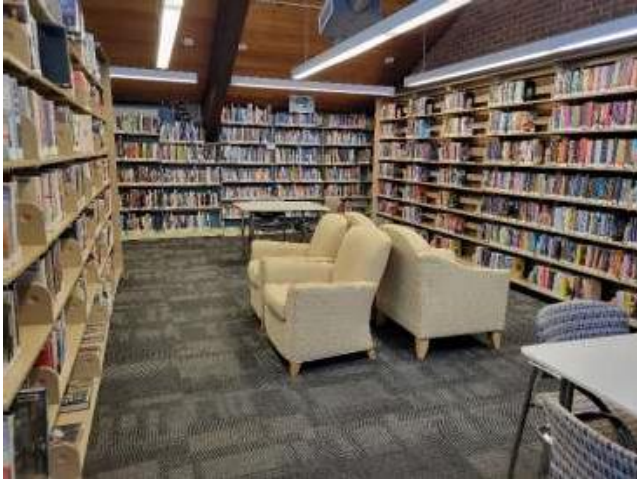
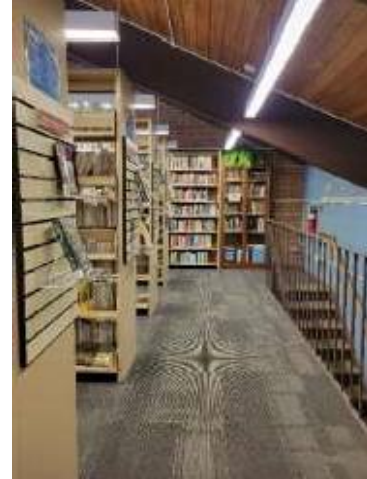
The Mezzanine space is open to the First Floor and is accessed by two stairs and the building elevator. The space includes collections, study counter, and lounge furniture. The space has access to natural light. As noted in other sections of the report, the bookstack aisles and the elevator pathway do not meet building or accessibility codes. Through minor modifications the collections could be made accessible. However, the elevator pathway would require significant changes.

- ▶ *Recommend the Library update the layout of the furniture and shelving at the Mezzanine to meet building and accessibility code. Refer to "Pathway" section in the "Accessibility" portion of this report for additional information on elevator access.*

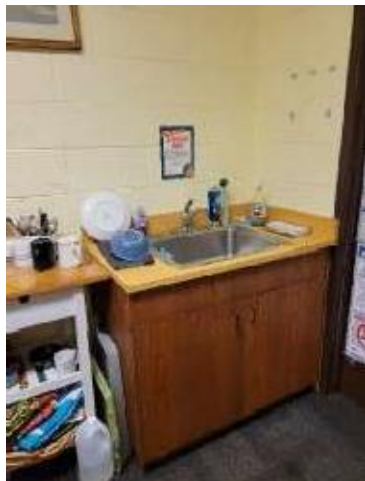
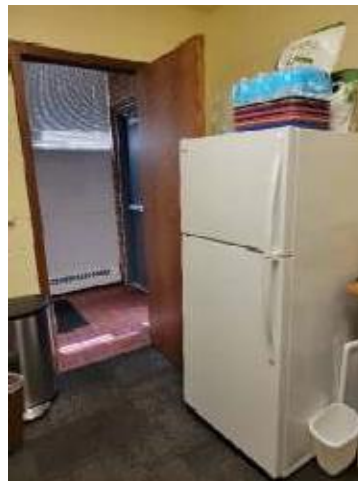
Staff Break Room Sink

Staff Break Room Equipment

- ▶ *We recommend the staff break room be brought up to the requirements of the Illinois Accessibility Code. This would include new cabinets and sink as well as furniture.*

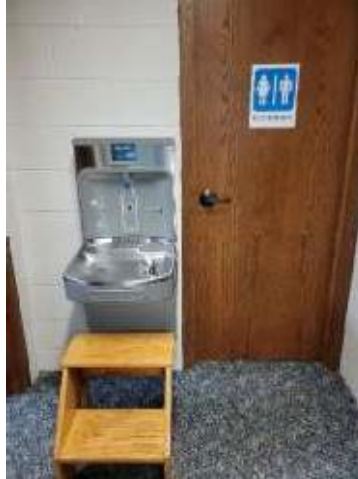
Lower-Level Stair Lobby Drinking Fountain

This area is directly at the bottom of the main stair and is the entry to Youth Services, has access to a small restroom and access to the Community Room. A drinking fountain was recently installed in the lobby and blocks accessible entry into the small restroom.

- ▶ *We recommend the Library relocate the drinking fountain to allow code required access to the restroom.*

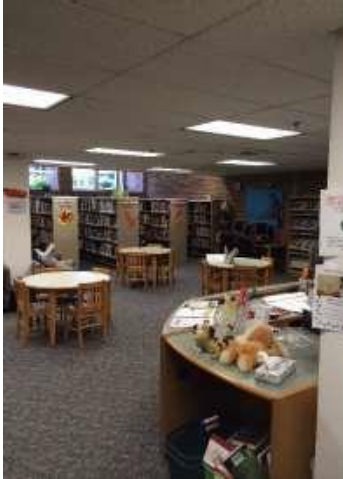
The space also includes the Youth Services Managers desk. The Youth Services department does not have a dedicated workroom. All Youth Services off desk work is done at the service desk. A combination service desk / work desk does help saves space but is very inefficient for staff and is hard to keep organized and clean.

The Library has used book stacks to create a makeshift office, however this space does not provide any privacy or security. Any patron at any time could enter this space and if the areas is not staffed have access to Library systems and personal items.

Main Entry to Youth Services

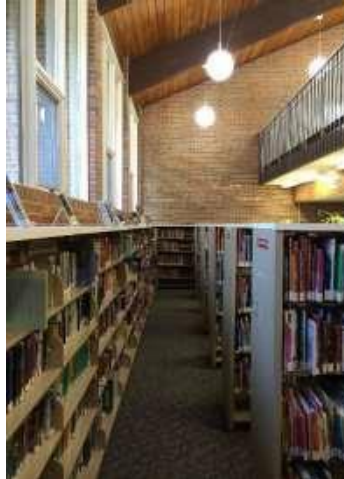
Open Mezzanine edge above Youth Services

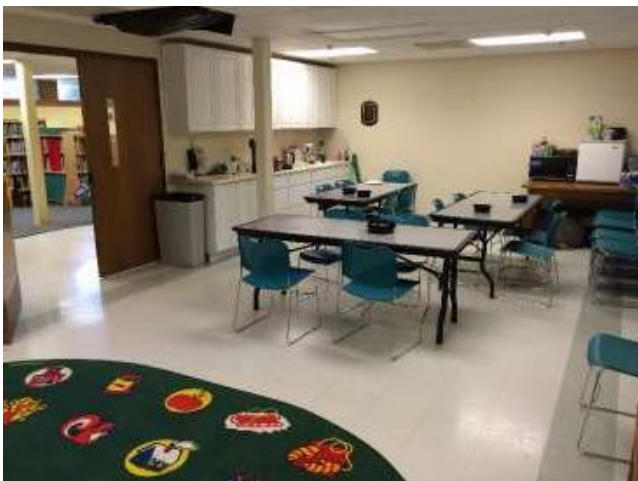
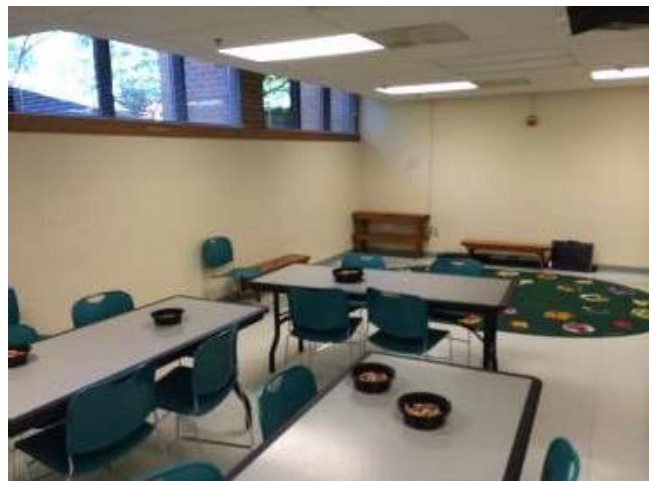
Program Room

The counter and sink in the room are not accessible. The counter is over 34 inches and the sink is in the corner which does not allow for a side approach.

- ▶ *We recommend the Library replace the cabinet and sink to meet accessibility code.*
