Lake Bluff Public Library Building Systems and Site Report

Revised | November 14, 2023

2022 Existing Conditions and Revision Recommendations Lake Bluff Public Library Lake Bluff, Illinois Visit Date: September 9, 2022

Lake Bluff Library Facility Assessment Report

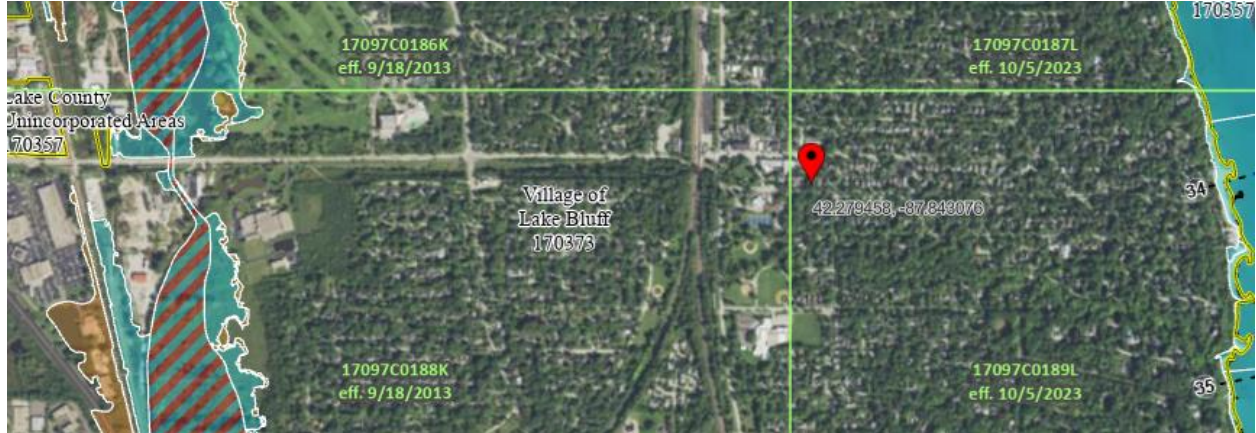
FEMA Flood Maps, pictured below, were reviewed to assess the likelihood of flooding in the area. There is no floodplain on-site, or in the vicinity of the site, based on FEMA Flood Maps. Utilizing Lake County GIS maps, the floodplain elevation is approximately 670'. The road in front of the library is 681', an 11' difference. Based on the information, the likelihood of flooding coming from the floodplain is highly unlikely.

Ground elevations along E Scranton Avenue go from the library to the east, ultimately draining to Lake Michigan. Any water in the ROW will not drain toward the library. The storm sewer located in the southeast corner of the property appears to be in a low-lying area. Based on county GIS topographic information, the overland flow from this low-lying area goes thru the rear yards of two residence before discharging into Evanston Avenue. Evanston Avenue then drains to Scranton Avenue. EEA recommends having the pipe that drains this area rodded out every 4-5 years to ensure there is no build up of debris in the pipe.

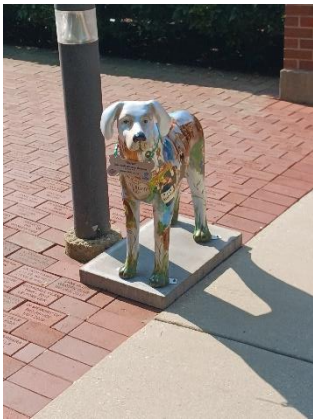
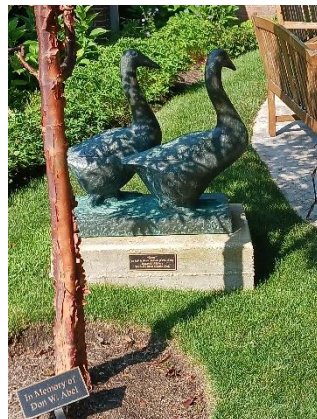
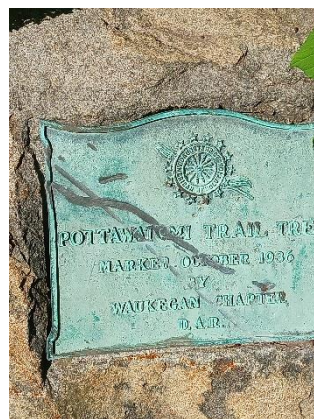
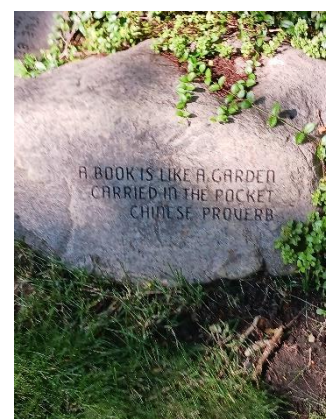
There are several statues, memorials, and donor bricks on the site. If any work is done on the site, the donor plaques should be preserved.
