# Lake Bluff Public Library Building Systems and Site Report

Revised | November 14, 2023

# Lake Bluff Library Facility Assessment Report

TO: Joe Huberty, Shaun Kelly – Engberg Anderson  
PROJECT: Fox Lake Library Facility Assessment  
DATE: 11/1/2023  
SENIOR PROJECT MANAGER: Ben Ahring, P.E.

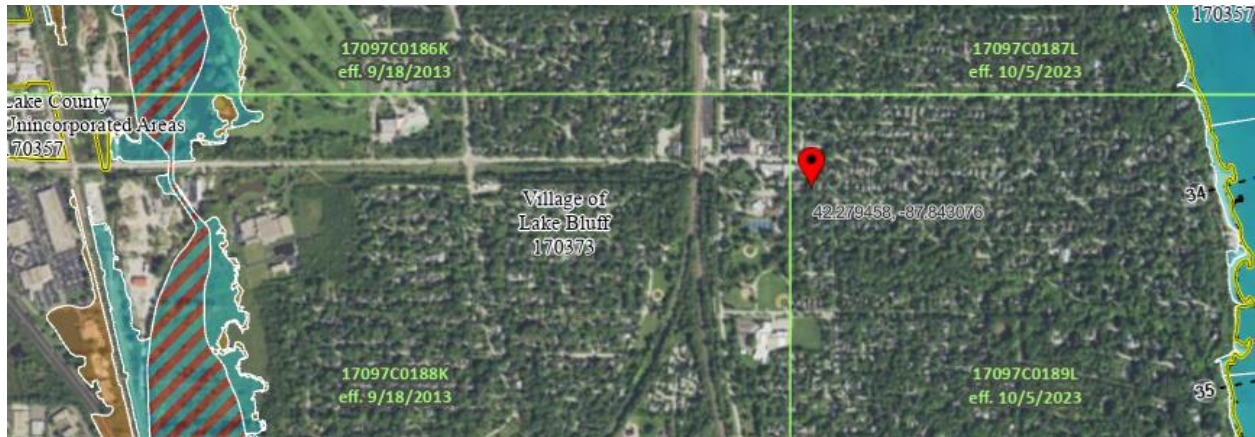
FEMA Flood Maps, pictured below, were reviewed to assess the likelihood of flooding in the area. There is no floodplain on-site, or in the vicinity of the site, based on FEMA Flood Maps. Utilizing Lake County GIS maps, the floodplain elevation is approximately 670'. The road in front of the library is 681', an 11' difference. Based on the information, the likelihood of flooding coming from the floodplain is highly unlikely.

Ground elevations along E Scranton Avenue go from the library to the east, ultimately draining to Lake Michigan. Any water in the ROW will not drain toward the library. The storm sewer located in the southeast corner of the property appears to be in a low-lying area. Based on county GIS topographic information, the overland flow from this low-lying area goes thru the rear yards of two residence before discharging into Evanston Avenue. Evanston Avenue then drains to Scranton Avenue. EEA recommends having the pipe that drains this area rodded out every 4-5 years to ensure there is no build up of debris in the pipe.

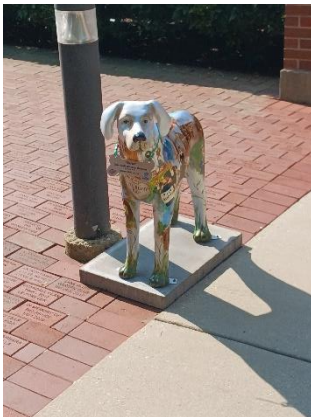
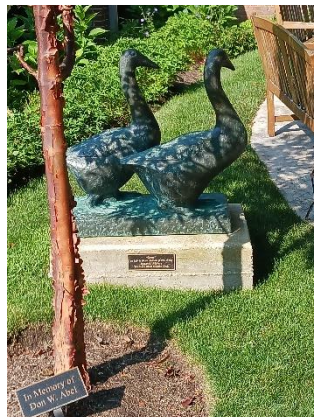
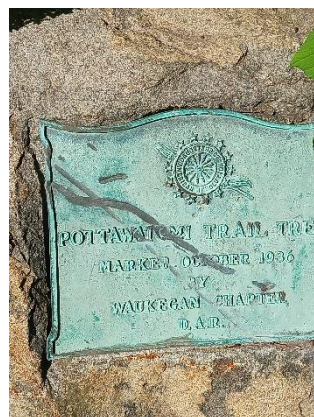
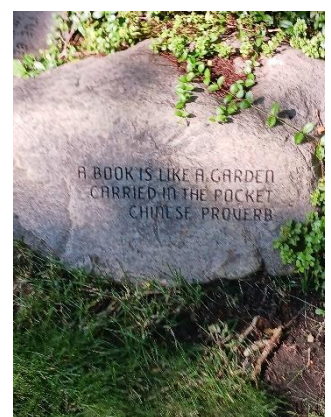
There are several statues, memorials, and donor bricks on the site. If any work is done on the site, the donor plaques should be preserved.
